SUBJECT: Hendersonville High School Report

Property Condition Assessment

Existing Stillwell Building (Circa 1924)

Inspection Dates: 1/22/2016 thru 3/3/2016

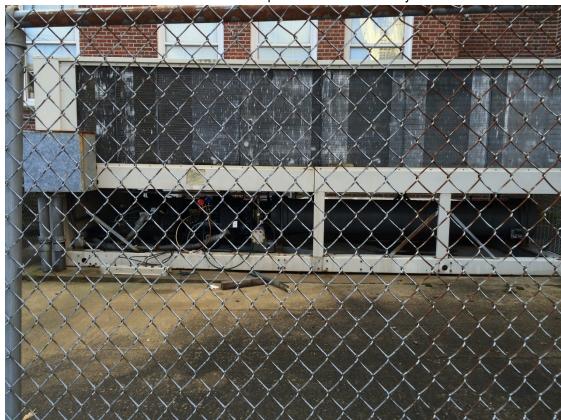
- HVAC As part of the new HVAC system the use of the existing McQuay chiller manufactured and installed in 1990 was briefly discussed but due to the condition and age of the chiller a new more efficient chiller needs to be included as part of the new HVAC system

Chiller Installed in 1990 in Working but Very Poor Condition

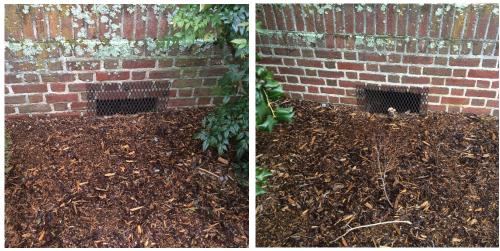
West Area Foundation Drains -West Classroom Wing

This area of the site needs to be regraded to create positive drainage away from the entire west side of main building. It appears that water is entering the crawl space thru foundation vents that are partially below grade allowing rainwater direct access to the crawl space. On the west side of the auditorium the exterior grade is up to 16" above the finish floor elevation. Due to the surrounding set site elevations such as the street, sidewalks adjacent to the street and main entry doors it is not feasible to totally correct this negative floor elevation situation but positive surface drainage away from the building (as well as below-grade waterproofing and foundation drainage) needs to be established to reduce the amount of water migrating to the exterior wall.

Recommendations, Costs and Priorities:

It is recommended to carry a \$200,000 Allowance as noted in Section 4.2 Cost Estimate

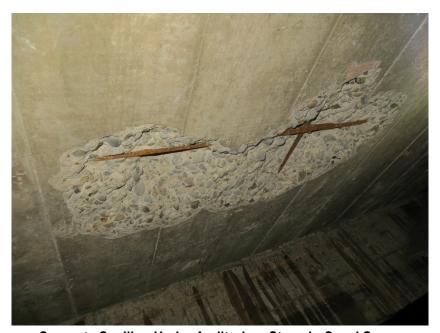
- Overall, the structural components visually inspected were found in generally satisfactory condition however we would highly recommend further investigation by a licensed structural engineer at the appropriate time.
 - oThe north courtyard unenclosed steel emergency stairs for floors 2 & 3 are in poor condition due to rust and need to be removed and replaced as part of the renovation. We would recommend new structures enclosing new emergency exit stairs at these locations.
 - Water infiltration to crawl space and foundation area along with water intrusion thru the exterior walls due to holes & cracks in the aging mortar joints was also noted.
 - Areas of concrete structure under Auditorium in crawl space showed signs of spalling. It is recommended to patch these areas.

Concrete Spalling Under Auditorium Stage in Crawl Space

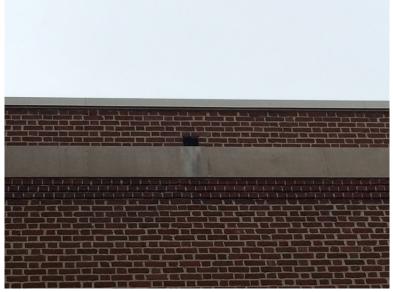
- Based upon the current condition of the entire roofing system consisting of but not limited to: membrane, flashing, copings and drains – it is our recommendation the entire roofing system be replaced. To meet the new energy code and due to the condition and type of roof system a new roofing system will also be beneficial in terms of energy consumption.
- Several overflow scuppers were observed not protruding out past the face of the exterior wall.
 The scuppers need to be replaced so that water is directed out past the exterior wall.

Overflow Scupper Not Protruding Past Exterior Wall

- Above observations are addressed in Section 4.1 Cost Estimate.
- It is our recommendation that the entire roofing system be replaced with a built up TPO or EPDM system, along with demolition of existing Flashings copings and drains, re-curbing and flashing roof top equipment a new coping system will also need to be installed. With the existing drainage pattern of the existing system the perimeter coping system may possibly have to be raised to accommodate the additional new layers of insulation required by the new energy code. Due to the aesthetics of the existing building it would be better during demolition and remodeling to change the drainage pattern to avoid this issue.

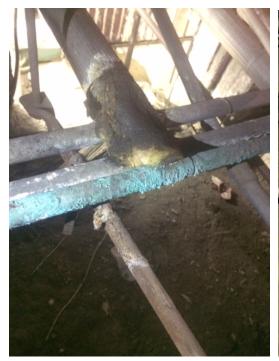
Crawl Space Water Piping

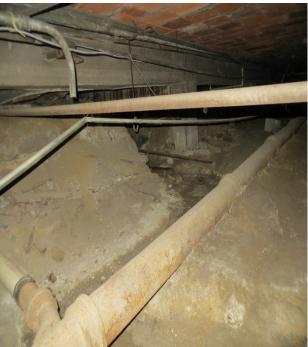
Crawl Space Cast-Iron Sewer Piping

- Age is the major deficiency noted in the plumbing system during the assessment. The plumbing system is generally in good working order but due to the age of the cast iron waste piping and fixtures we have included a new plumbing system complete to the exterior of the building.
- Possible changes to restroom and other wet area locations and modifications to existing chase locations also is a determining factor to replacing the entire plumbing system.
- A significant amount of the existing pipe insulation is damaged especially in the chases.

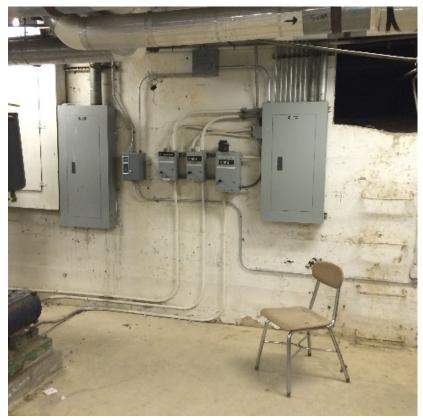
- Building Electrical Main Service Currently the building has an existing Siemens 208Y/120 VAC 3000 AMP MDP Panel and associated circuit panels and breakers. Although in "working" condition due to the age of the equipment manufactured and installed in 1990 concerns with the ability to carry the new building service requirements, failure rate of 25 year old components and the lack of a warranty on critical electrical system components it was concluded that this equipment needs to be replaced as part of the new electrical system

Circuit Panels in Boiler Room
