February 7, 2022

Subject: **Report of Limited Asbestos Sampling and Analysis**
VFW Building Renovation Project
Hendersonville, North Carolina
BLE Project No. J21-17262-01

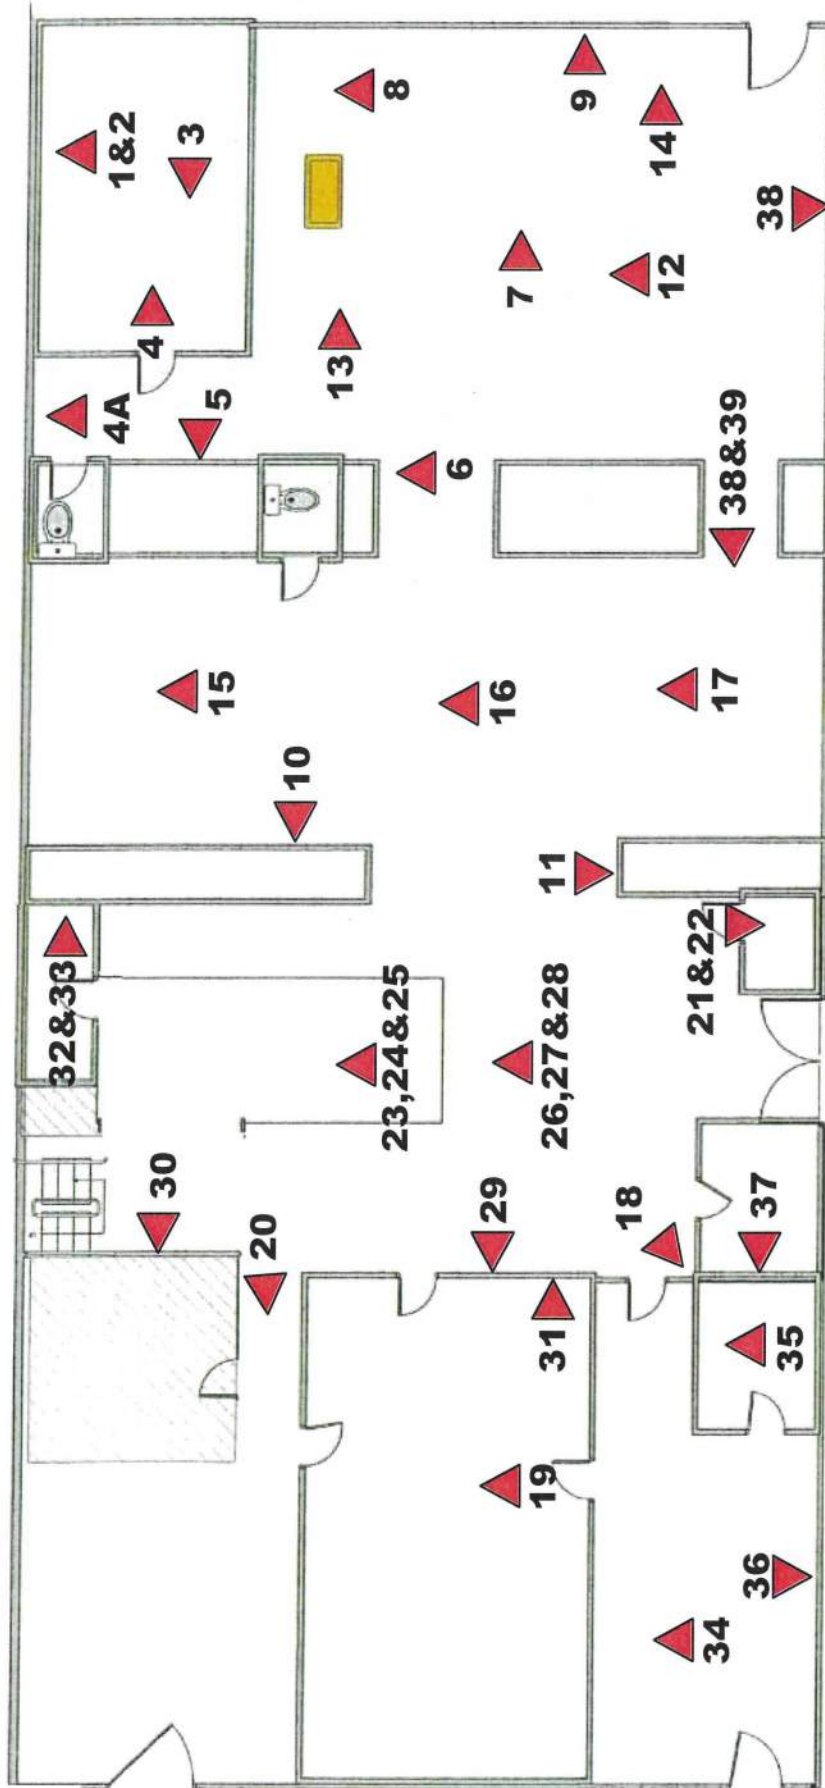
BUNNELL LAMMONS ENGINEERING	Drawn By: SCI	VFW Building Renovation Project Lower Level Henderson County, North Carolina BLE Project No. J21-17262-01	Asbestos Sample Location Map	Figure No. 1
	Date: Feb 2022

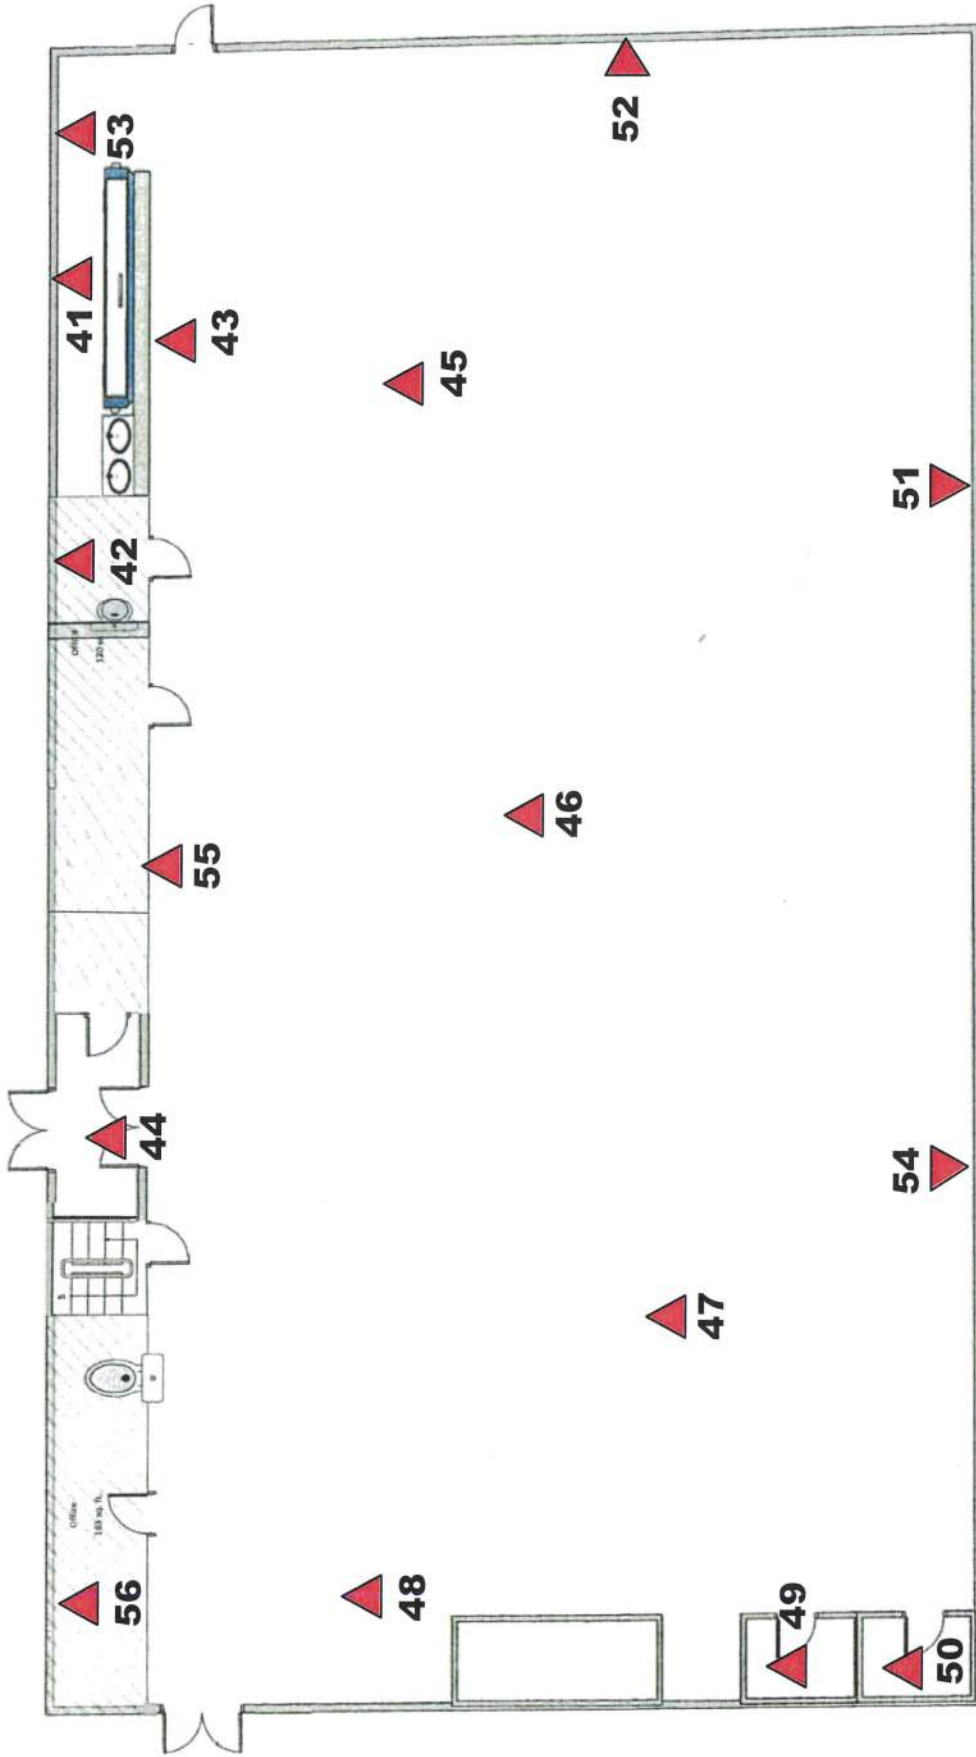
Figure No.
2

VFW Building Renovation Project
Upper Level
Henderson County, North Carolina
BLE Project No. J21-17262-01

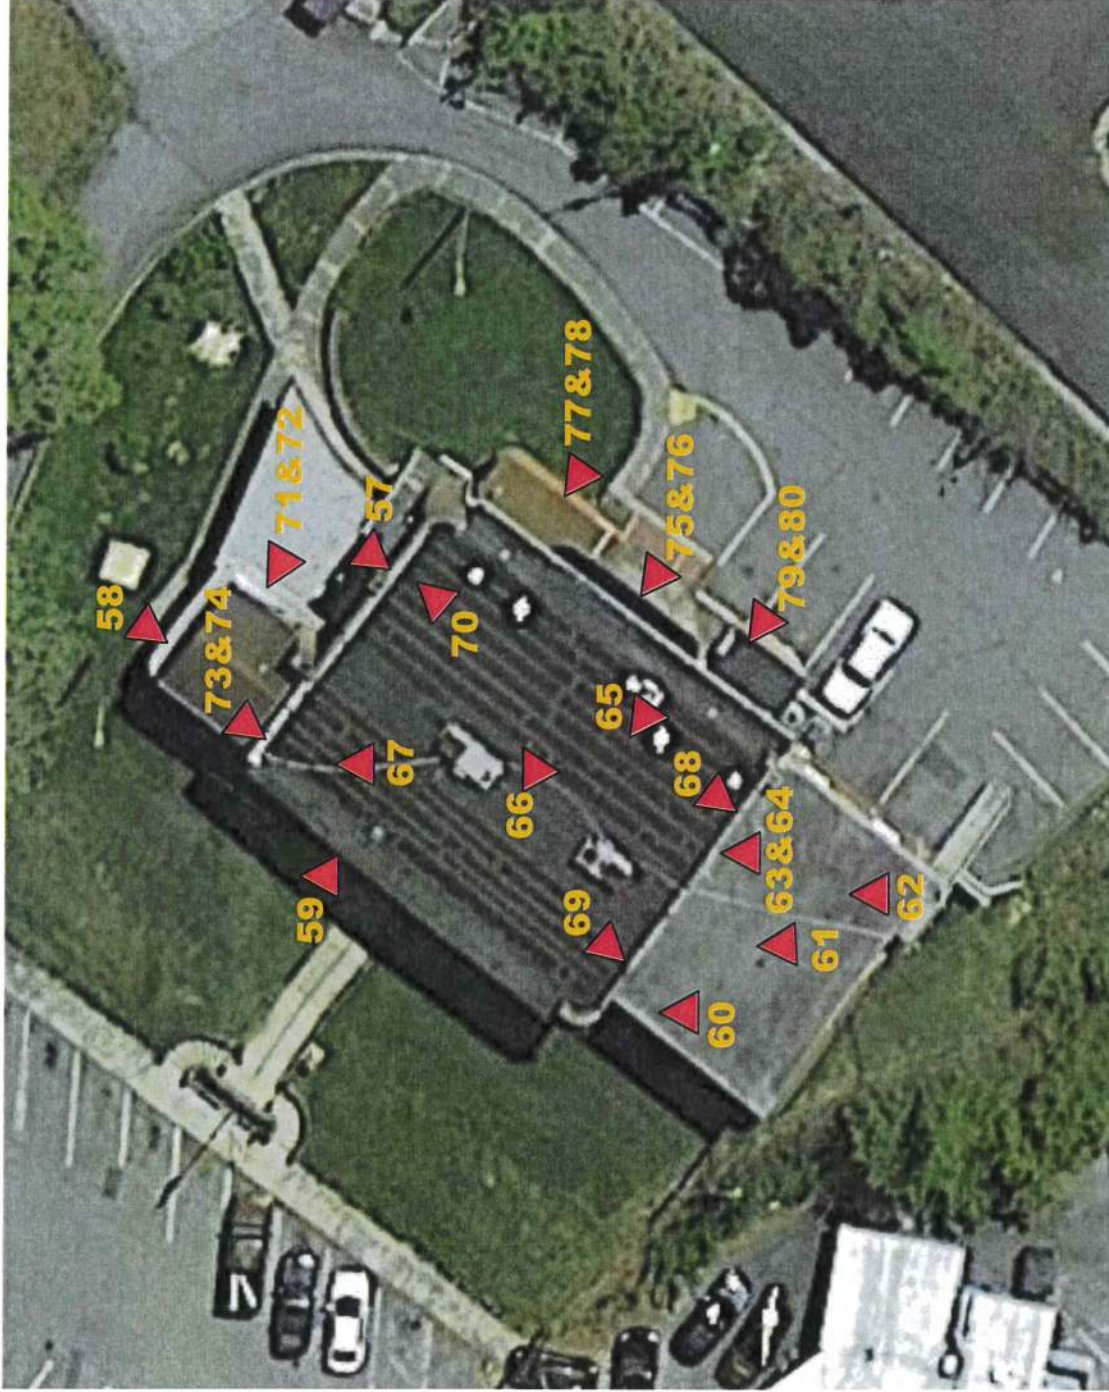
BUNNELL LAMMONS ENGINEERING	Drawn By: SCI	VFW Building Renovation Project Exterior/Roof Henderson County, North Carolina BLE Project No. J21-17262-01	Asbestos Sample Location Map	Figure No. 3
	Date: Feb 2022

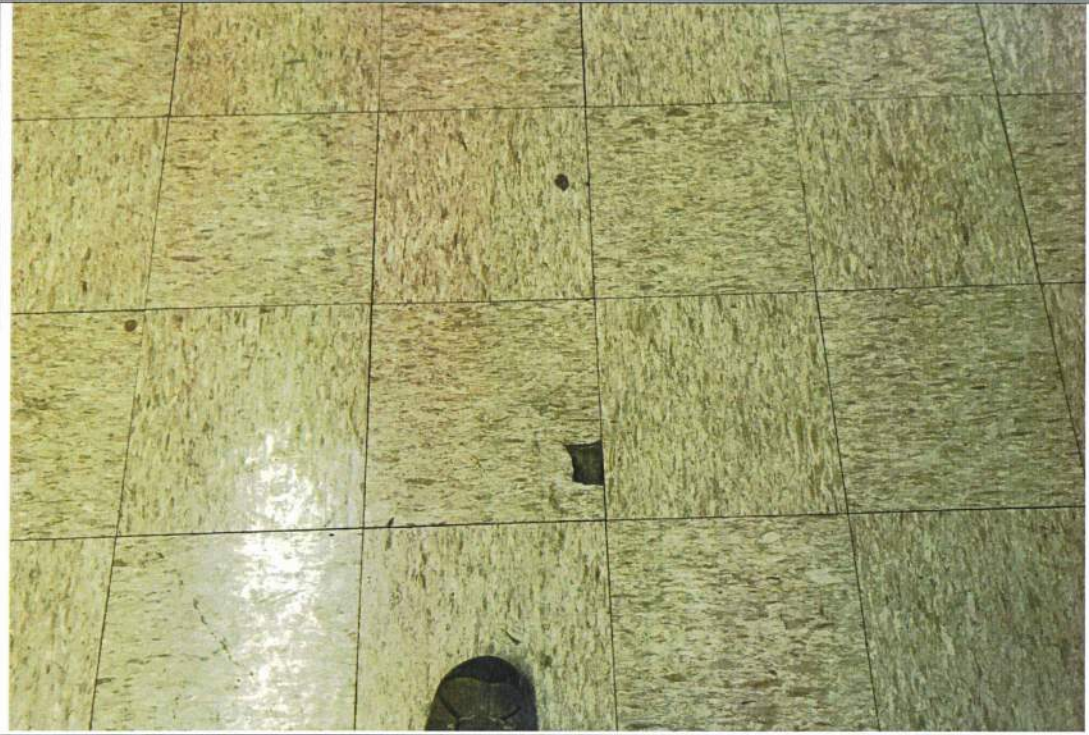
3	Location / Orientation	Lower Level Game Area
	Remarks	Floor Tile and Mastic

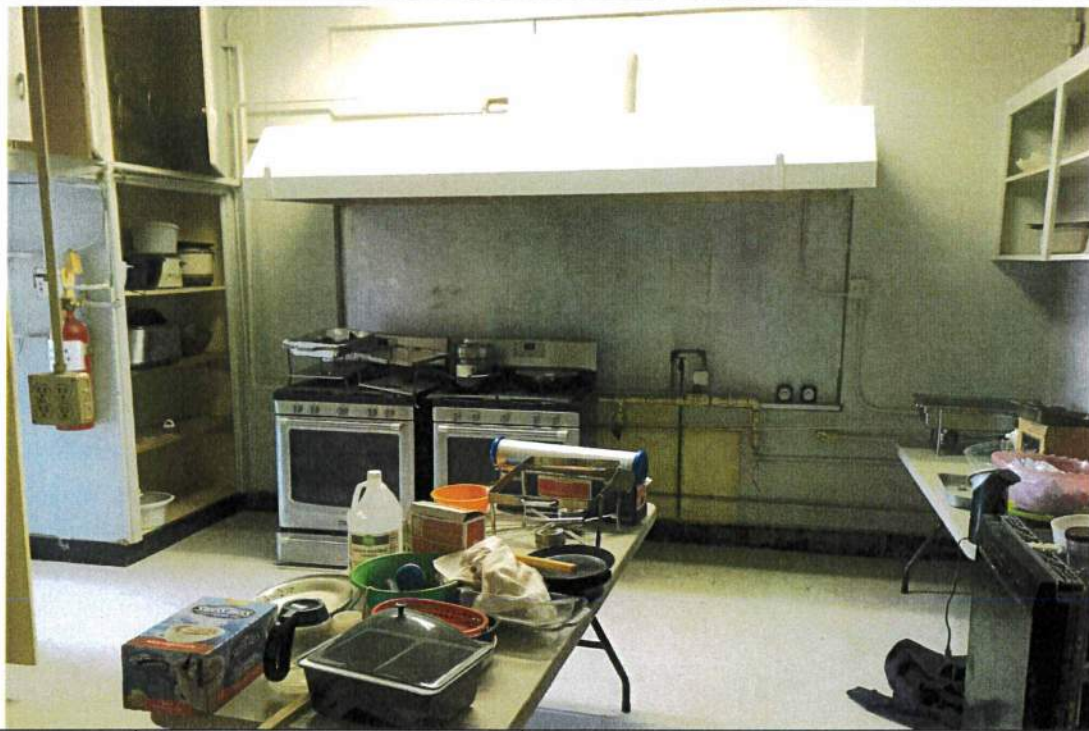
4	Location / Orientation	Lower Level Kitchen Area
	Remarks	Floor Tile and Mastic

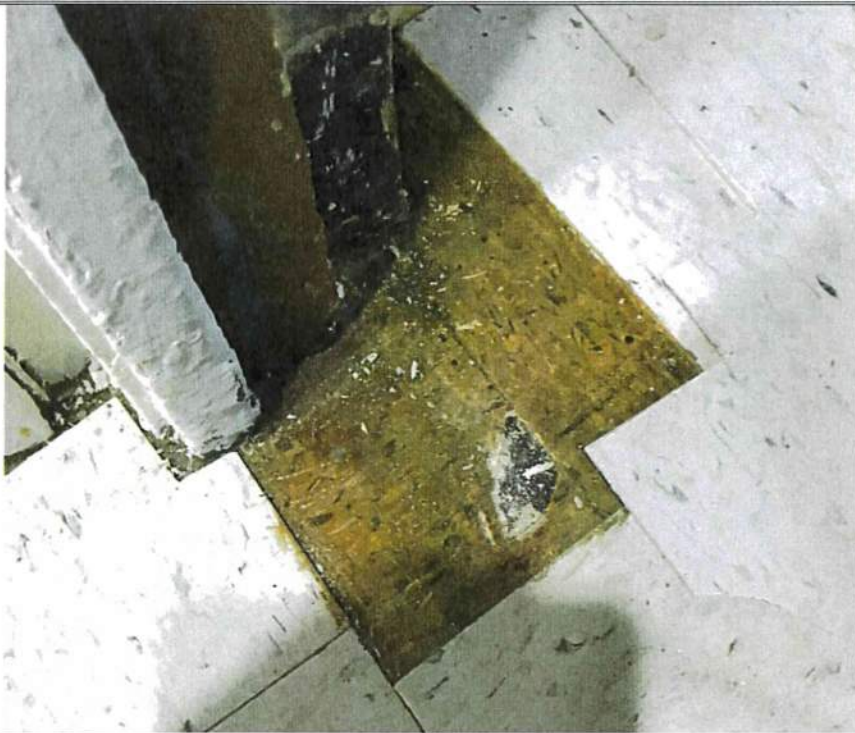
7	Location / Orientation	Lower Level Hallway near Dining Area	Photographer S. Interlicchia	Date: Jan 22
	Remarks	Two layers of floor tile and mastic

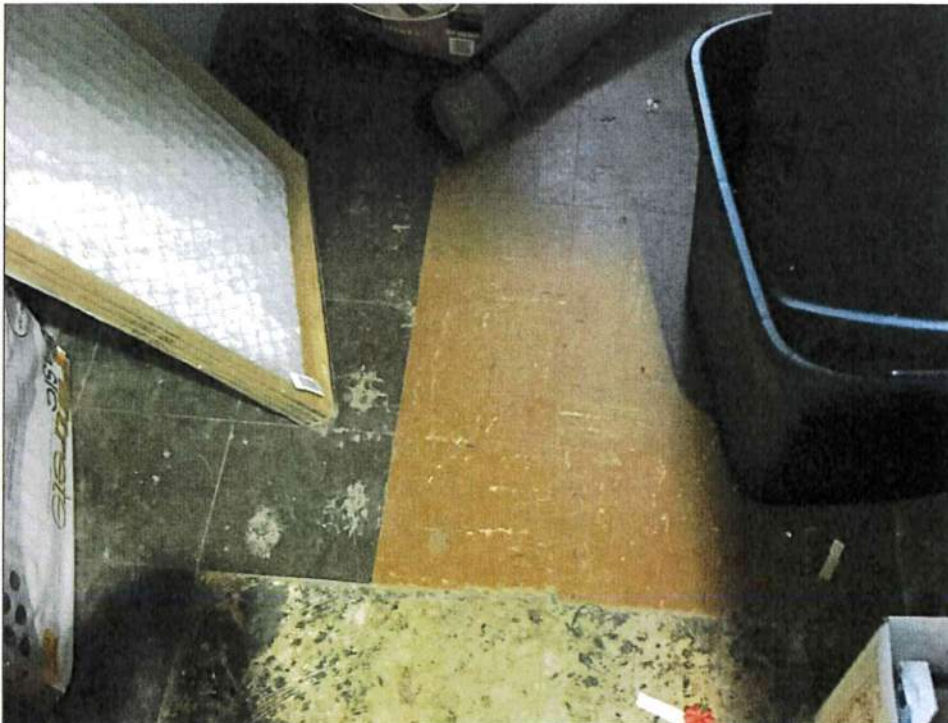
8	Location / Orientation	Lower Level West Storage Closet	Photographer: S. Interlicchia	Date: Jan 22
	Remarks	Floor Tile and Mastic

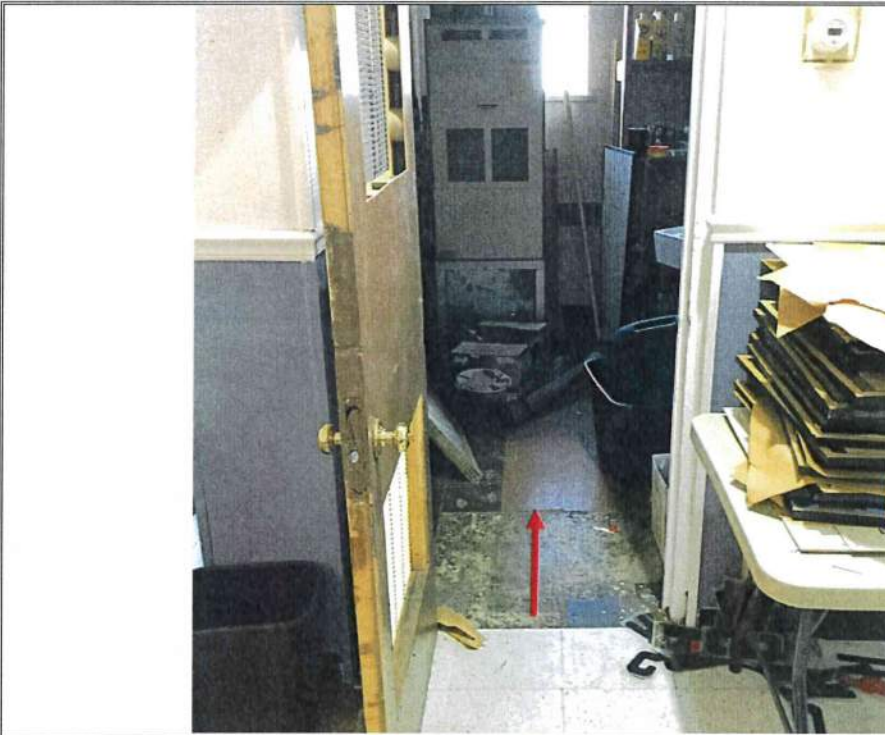
9	Location / Orientation	Lower Level West Storage Closet	Date: Jan 22
	Remarks	Floor Tile and Mastic

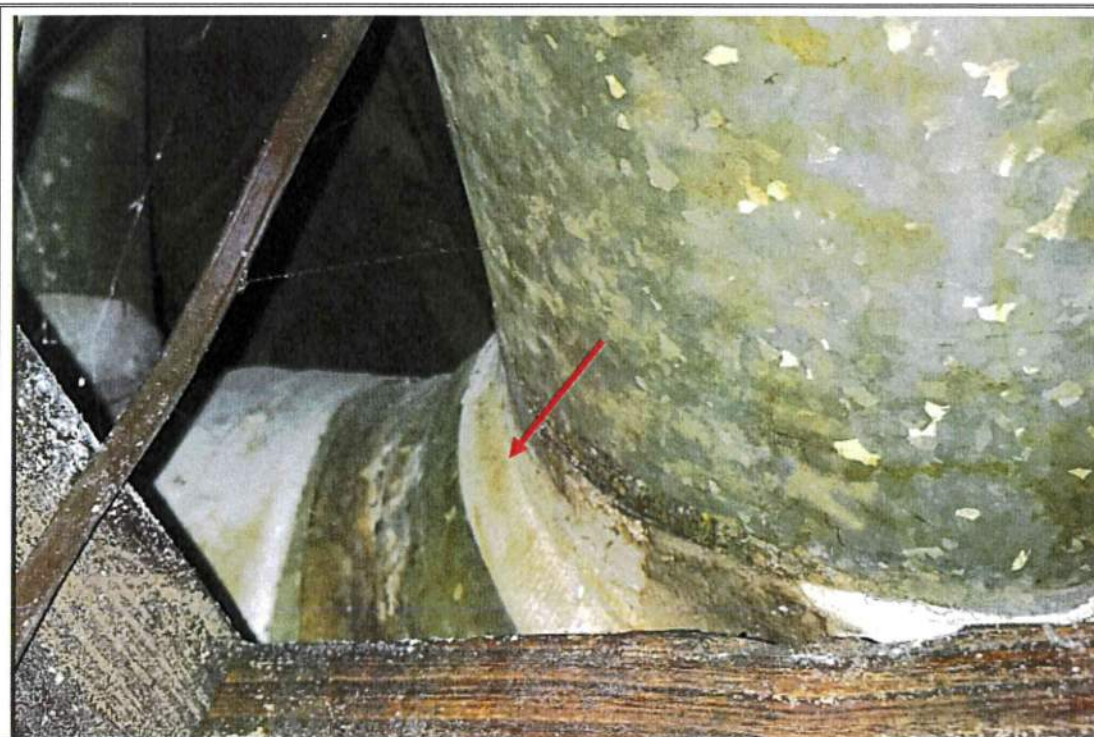
10	Location / Orientation	Lower Level Metal Duct	Date: Jan 22
	Remarks	Metal Duct above ceiling Visible in Bar Storage Area

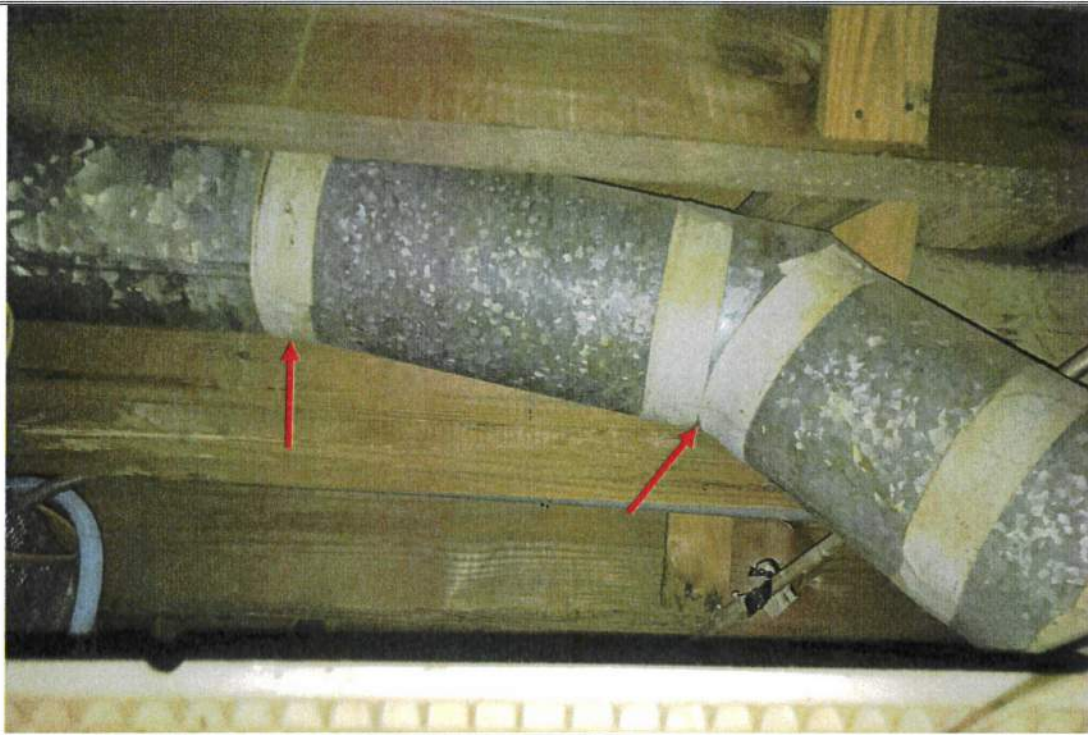
11	Location / Orientation	Lower Level Metal Duct	Date: Jan 22
	Remarks	Insulation Tape on joints Duct above ceiling

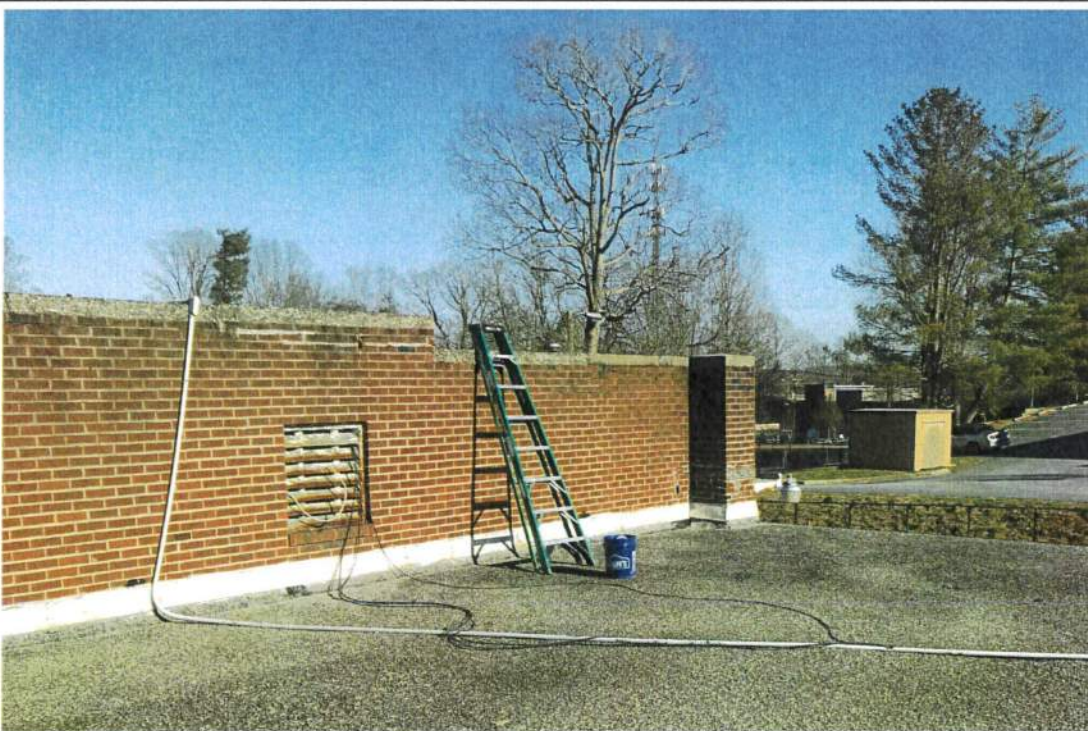
12	Location / Orientation	Southside Lower Roof	Date: Jan 22
	Remarks	BUR and Flashing

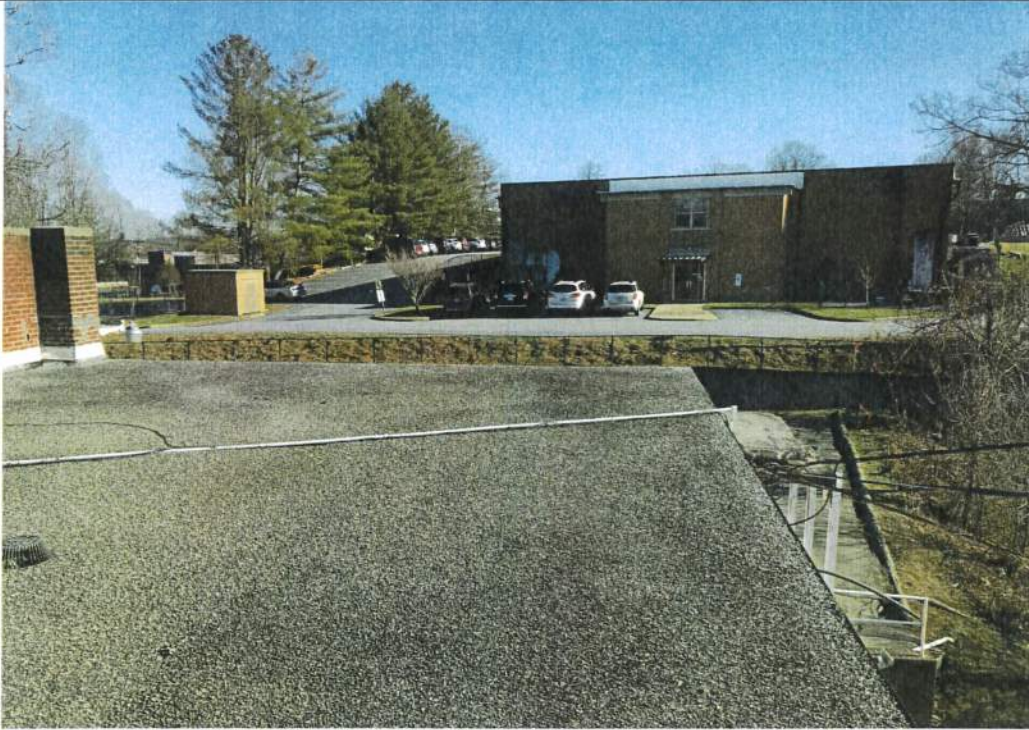
13	Location / Orientation	Southside Lower Roof
	Remarks	BUR

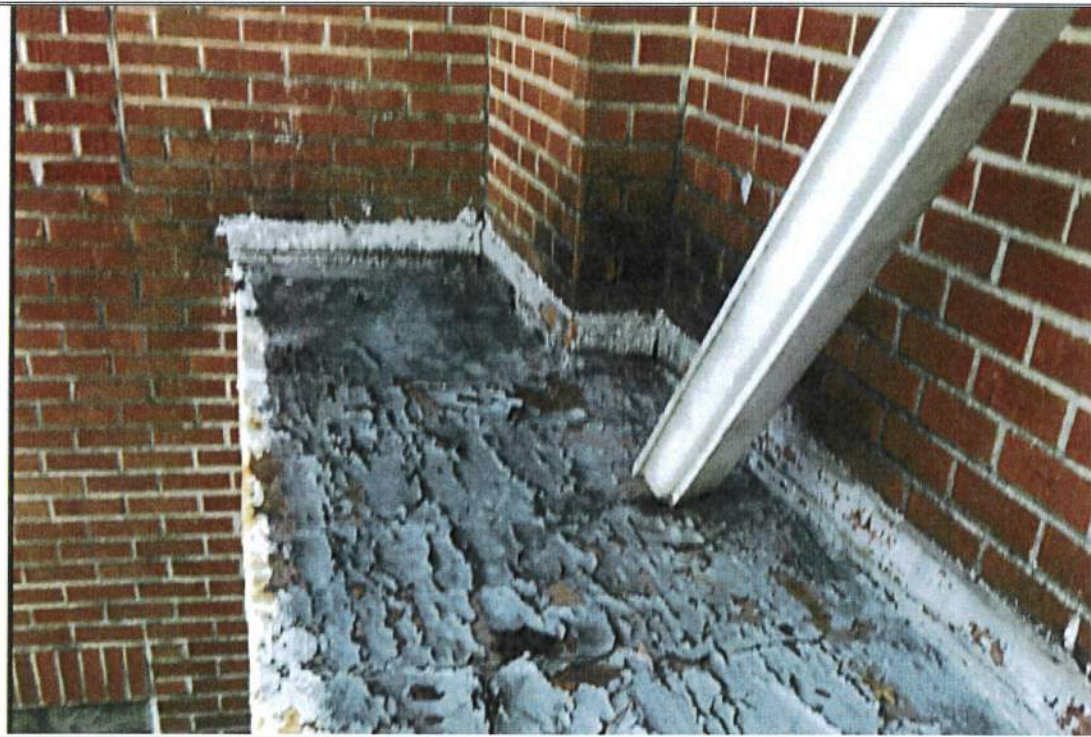
15	Location / Orientation	Southside Canopy Roof	Date: Jan 22 Photographer S. Interlicchia
	Remarks

71 & 72	roofing and coating	northside canopy roof (photos #14 & 15)	3% to 5% chrysotile (coating) 8% chrysotile (roofing)
73 & 74	parapet coating/flashing	main roof north parapet (photo #16)	3% chrysotile (coating) 6% chrysotile (roofing)
75 & 76	roofing	eastside canopy roof (photos #17 & 18)	4% chrysotile

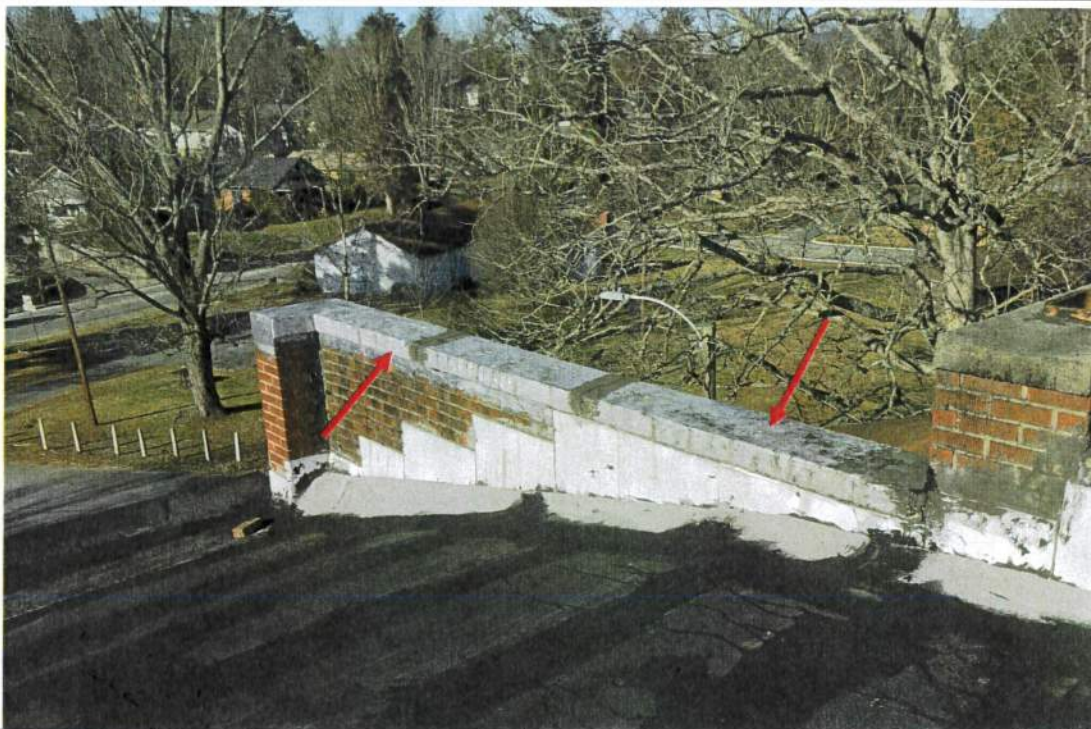
16	Location / Orientation	Main Roof North Parapet	Date: Jan 22 Photographer: S. Interlicchia
	Remarks	Silver colored coating
