### Addendum #1

#### *Henderson County - South Grove Street Parking Improvements*

**RE: Final Report - Asbestos Inspection – Private Residence  
101 South Grove Street - Hendersonville, North Carolina**

**Asbestos Inspection Final Report  
Private Residence  
101 South Grove Street  
Hendersonville, North Carolina**

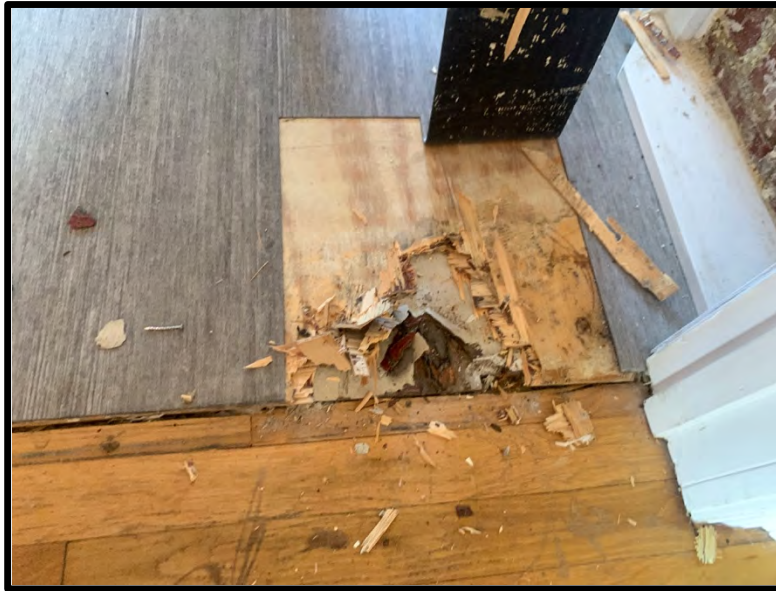
Homogeneous Area A-07 is the brown wood square pattern vinyl sheet flooring with underlayer of red vinyl sheet flooring and black mastic located in the bathroom. There is approximately 70 SF of this non-friable material, which is currently in good condition and located under new vinyl plank flooring. *See Photograph No. 1 attached in Appendix B.*

| <u>Sample No.</u> | <u>Location</u> | <u>% Asbestos/Type</u> |
|---|---|---|
| A-07-01-C (VSF 2/Mastic) | Bathroom | 20 % / Chrysotile |

**Photo No. 1 – Homogeneous A-07 Brown Wood Square Pattern  
Vinyl Sheet Flooring with underlayer of Red Vinyl Sheet Flooring  
and Black Mastic (Only Underlayer of VSF and Mastic is Asbestos Containing)**

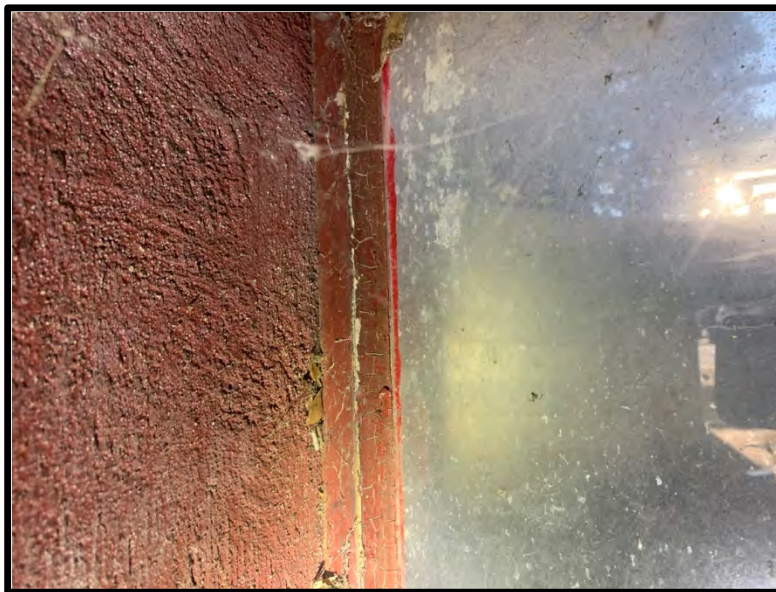
Homogeneous Area A-11 is the metal window interior glazing located on 5 basement windows of the residence. There is approximately 50 LF of this non-friable material, which is currently in poor condition. *See Photograph No. 2 attached in Appendix B.*

**Photo No. 2 – Homogeneous Area A-11 Metal Window Interior Glazing**

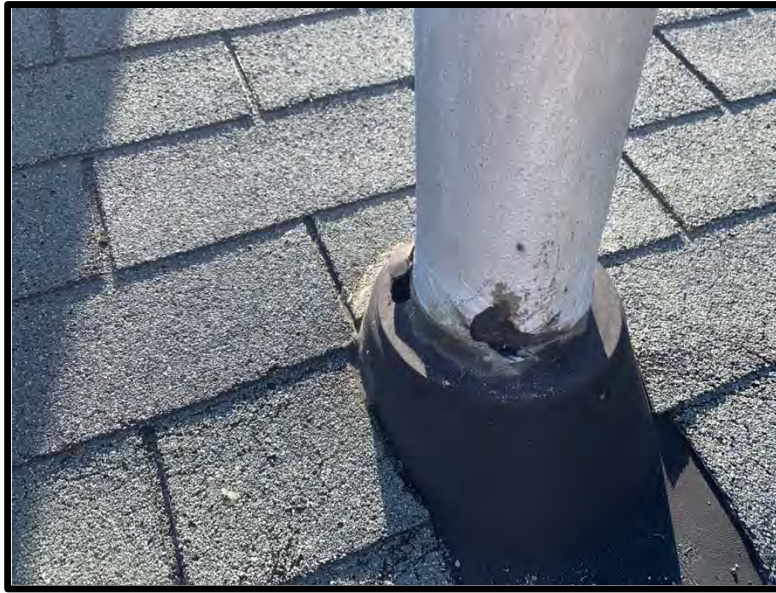
Homogeneous Area A-14 is the silver painted black flashing material located around two (2) penetrating pipes on the roof of the residence. There is approximately 2 SF of this non-friable material, which is currently in good condition. *See Photograph No. 3 attached in Appendix B.*

**Photo No. 3 – Homogeneous Area A-14 Silver Painted Black Flashing Material**

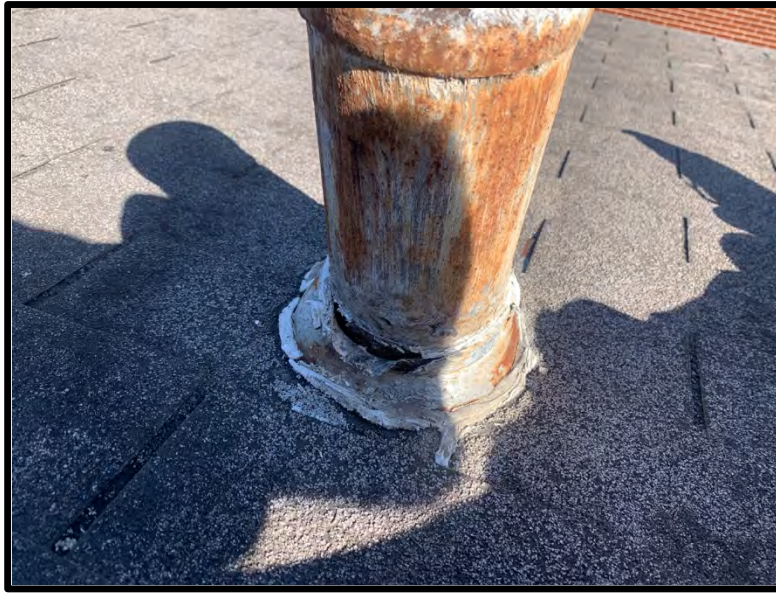
Homogeneous Area B-13 is the black flashing material located around three (3) penetrating pipes on the roof of the residence. There is approximately 3 SF of this non-friable material, which is currently in good condition. *See Photograph No. 1 attached in Appendix B.*

**Photo No. 1 – Homogeneous Area B-13 Black Flashing Material**
