SUBJECT: Presentation of Historic Courthouse Energy Study

Energy Assessment, Final

Henderson County Historic Courthouse Hendersonville, NC

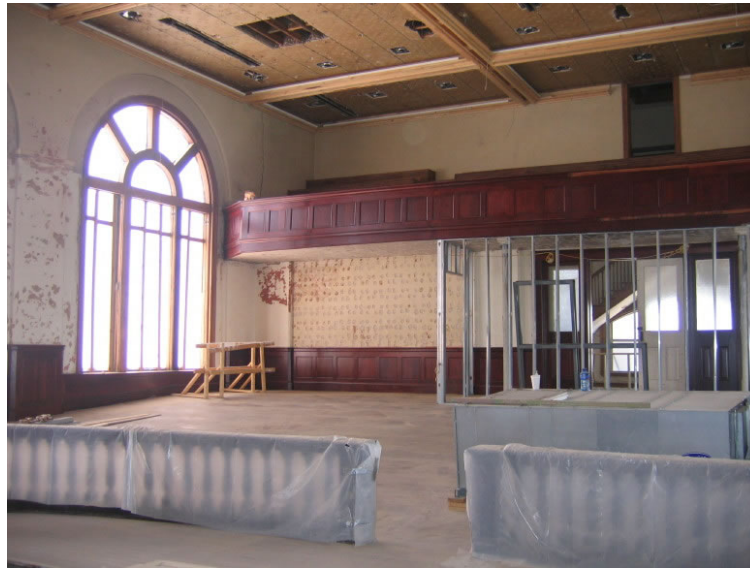
- e. The ceilings in the upper floor rooms have many cutouts for recessed can lights as shown in the picture below. A fabricated fire-rated light box will be installed over each lighting assembly to block air flow. Nine inches of un-faced fiberglass insulation will be installed over the existing blown-in insulation and the light boxes. The R-value of the finished ceiling assembly will be greater than 30.

Historic Courthouse ceiling rehabilitation
